**To:** Fire Chief: Fred Swen  
**From:** W. L. Robson, Major Projects Division  
**Date:** May 15, 2007  
**Subject:** **STRUCTURAL REVIEW OF WATER DAMAGE AT NIKISKI FIRE STATION #2, HOSE TOWER**

On May 8, 2007, Kyle Kornelis and Rob Robson, of KPBM-MPD reviewed the hose tower structure at Nikiski Fire Service Area, Sta. #2. This report is to state those observations.

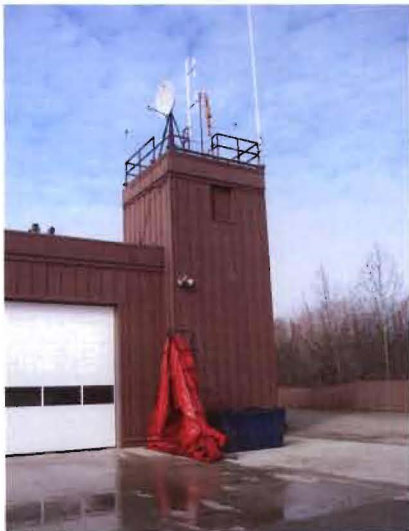
Pic #1 South-west View

The all wood structure, built in the early 1980's, is approximately 12' X 12' and ~ 28' tall. (See Pic. #1, & #2). Schematic drawings from Carmen Gintoli Arch., were the only versions found demonstrating this structure as proposed in 1979. No formal detailed design drawings were located and it is understood to be volunteer built. It is understood that the structure is leased from a separate party.

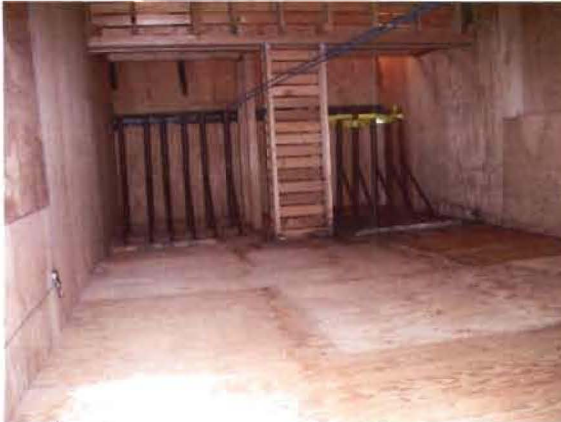
The inside portion of the structure has a sliding, plywood, guillotine-type, rope-operated door, separating it from the apparatus room. A metal, caged ladder leads to a wood, 2"X work platform (catwalk) allowing access to pipe hose hangers. The east side of the inside tower walls demonstrate moderate to severe deterioration. This is due to a combination of parameters, e.g.: hose-water dripping, roof leakage and thermo-condensation. It should be noted that the design of attaching a tower to any lower-elevation, warm space will inheritably attract moist air which condenses in the (cooling) tower walls. Some portions of the 2"X horizontal wood pipe-rack carrier member, has degraded to full deterioration in the center portion.

Pic #3 View up tower East Side

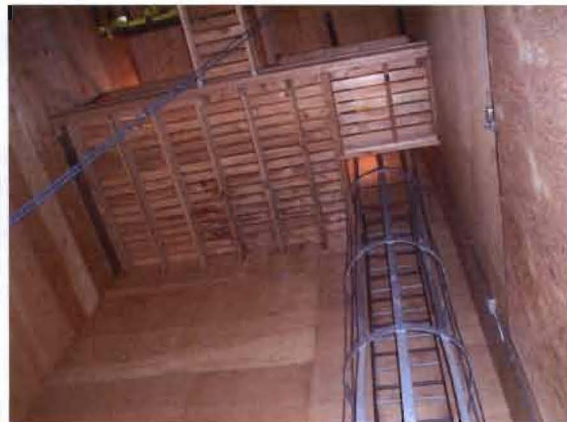
Pic #4 View up tower West side

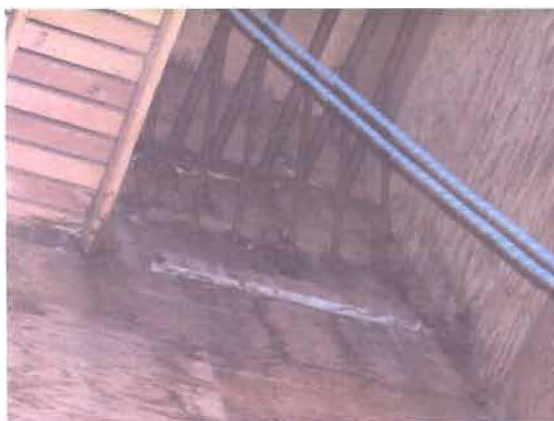
Pic #5 Hose Hanger area rot/deterioration

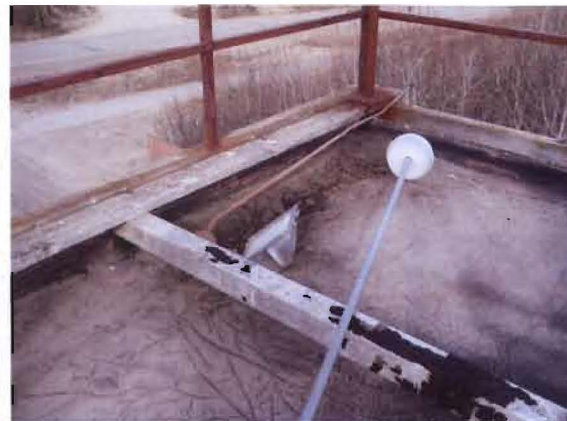
The insulated, non-ventilated structure appears to be constructed with 2"X 6" studding at 2' C-C's, with rough-cut plywood and 1"X 2" exterior batting. One (1) elevated training door, to the outside wall, (threshold at approx. 20' height). The roof structure has an assortment of antennae and a satellite dish (roof-surface affixed) with metal railing around the periphery. The roof surface of built-up bitumen sheets, is in poor condition, exhibits extensive cracking, separation of through-roof metal supports as well as sagging. The latter is due to suspected joist and sheeting failure, on the south side in the roof structure. Minimal weight carrying capacity exists in the roof structure. No obvious rain/snow-melt pour-off point is obvious. The metal, surround-railing has been supported on a horizontal 4"X 4" beam, which has suffered deterioration and allowed some of the leg attachment points to come loose. A structure light and an area light fixture are also on the roof but presently laying down and presumed inoperative.

Pic #6 SW Roof area (5' slump under light)

- Stop use of the tower;
- Secure inside access to eliminate any, unauthorized access to the tower area. Access should be designated as "Hard Hat Area" only;
- Remove and relocate from the roof structure, those antennae and dish, (presumed salvageable) to eliminate further wind-transitional load to the failing roof;
- Have constructed and placed, a structural, (50#/SF) waterproof, temporary cap, that would bear on the outside walls, eliminating any further load on the present roof and thusly eliminating precipitation accumulation and/or leakage (if some form of the structure is to remain);
- Eliminate all power service to structure;
- Review lease agreement as to liability sustainability.
