Exhibit B Jacobs Ladder Drive

TRAIL ASSESSMENT –JACOB’S LADDER TRAIL  
NPS-Rivers, Trails, and Conservation Assistance Program

On Friday, July 1, 2004, Kevin G. Meyer with the National Park Service’s Rivers, Trails and Conservation Assistance Program made a on-site inspection and assessment of the Jacob’s Ladder Trail located approximately 4 miles north of the Capt. Cook State Recreation Area. The work has completed at the request of Ms. Crista Cady, Planner for the Kenai Peninsula Borough. The purpose of the assessment was to make recommendations for improving the trail alignment to a sustainable condition. Those recommendations are as follows:

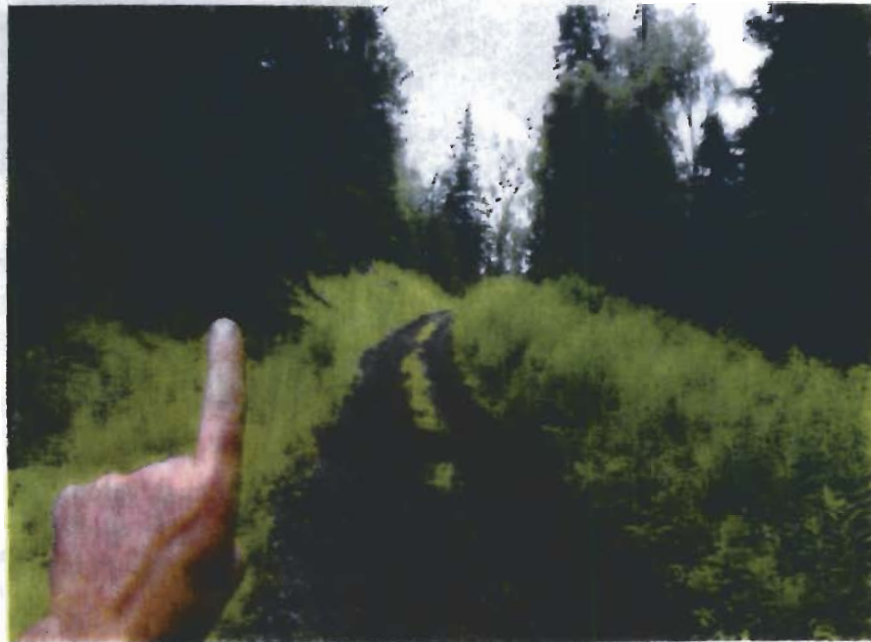
This section of the trail is presently usable and appears to be in a sustainable condition as demonstrated by the good trail surface condition and absence of trail widening or braided trail conditions. The trail is well drained and the tread surface is mixed fine mineral and gravel. Trail grade is less than 10%.

Photo 1. Looking west along trail towards Station #2

Recommended action: Rough grade existing surface to width, top cap with 6 inches of crushed gravel, shape trail surface to crown and compact.

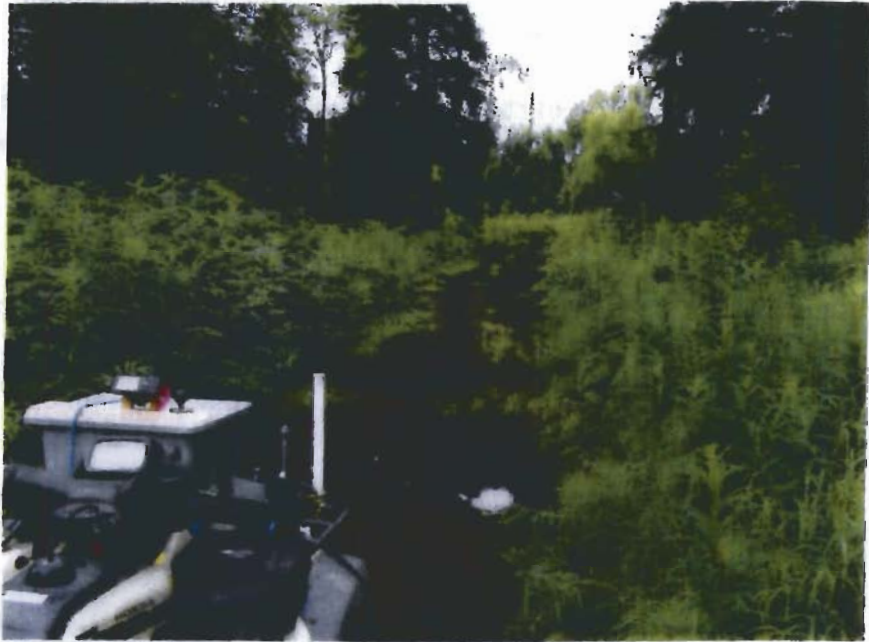
This segment of the trail is showing indications of degradation. The surface has developed shallow depressions, is muddy and holds water on the surface along the alignment. Local soils are developed in deep layers of silt that are poorly to moderately well drained and do not support heavy trail use when wet. Trail grade is 1-3%.

Photo 2. Trail segment between Stations 1 and 2.

Recommended action: Rough grade existing surface to width, install geotextile separation layer, top cap with 8-10 inches of crushed gravel, shape trail surface to crown and compact.

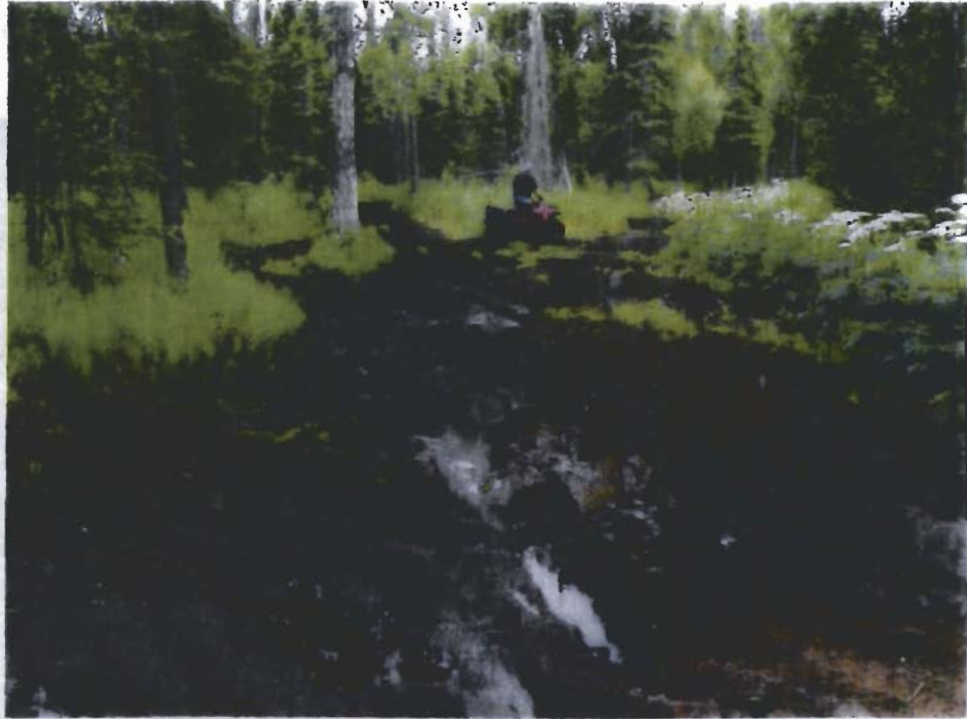
This segment of the trail is severely degraded. It has developed deep bogholes, extremely muddy conditions and is severely braided. Braided areas are easily 40 feet wide in places along the alignment. Soil conditions are poorly drained to saturated deep layers of silt. Surface slope is 0-1%.

**Photo 3. Severely degraded trail conditions between Station 3 and 4.**

**Recommended action:** Rough grade to width and fill in bogholes. Place geotextile separation fabric along alignment. Place 3-4 feet of rubble, cobble or course pit run material over geotextile. Rough grade surface and place another layer of separation fabric. Top cap with 8-10 inches of crushed gravel, shape trail surface to a crown and compact. Allow surrounding areas to naturally re-vegetate.

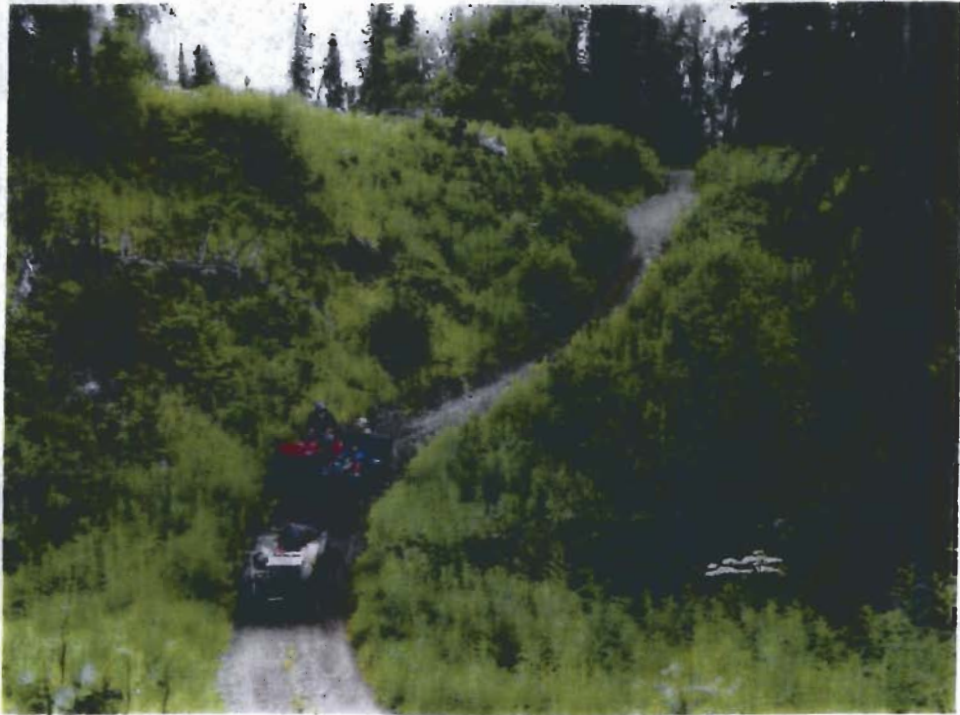
This segment begins the descent to the beach across some over steepened terrain. the trail grade is approximately 25% which exceeds the capacity of the site to support trail use without degradation –as indicated by erosion of the tread surface.

Photo 4. Looking back on over steepened slope between Station 5 & 6.

Recommended action: Reduce trail grade to less than 20% by borrowing material from reshaped area between Stations 6 and 8. Utilize local material for tread surface. Grade to width, shape with 5% outslope, and compact.

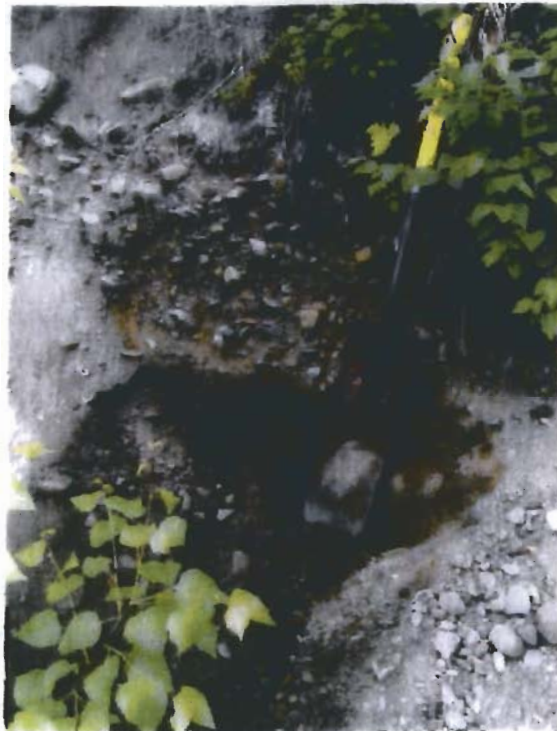
Soil conditions along the trail throughout the steep trail sections consist of alluvial gravel and sands.

Photo 5. Soil character along trail down steep slope sections.

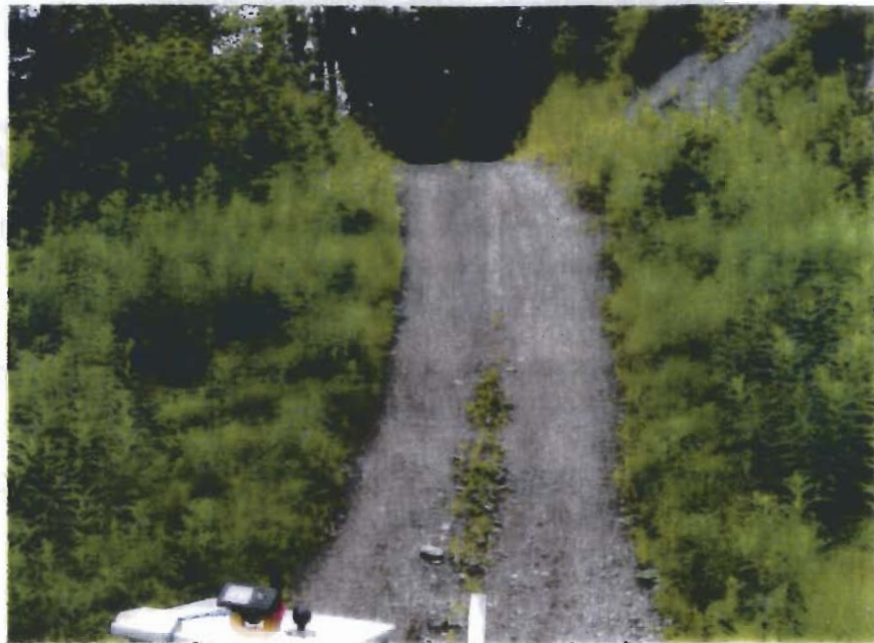
This is another over steepened section of trail. It has a grade of approximately 30% but it does not display evidence of erosion and material displacement from traffic. This is probably due to the relatively high quality tread material and short slope length.

Photo 6. Steep grade between Stations 6 and 7.

Recommended action: Reduce trail grade to less than 20% by excavating material. Utilize local material for tread surface. Grade to width, shape with 5% outslope, and compact.

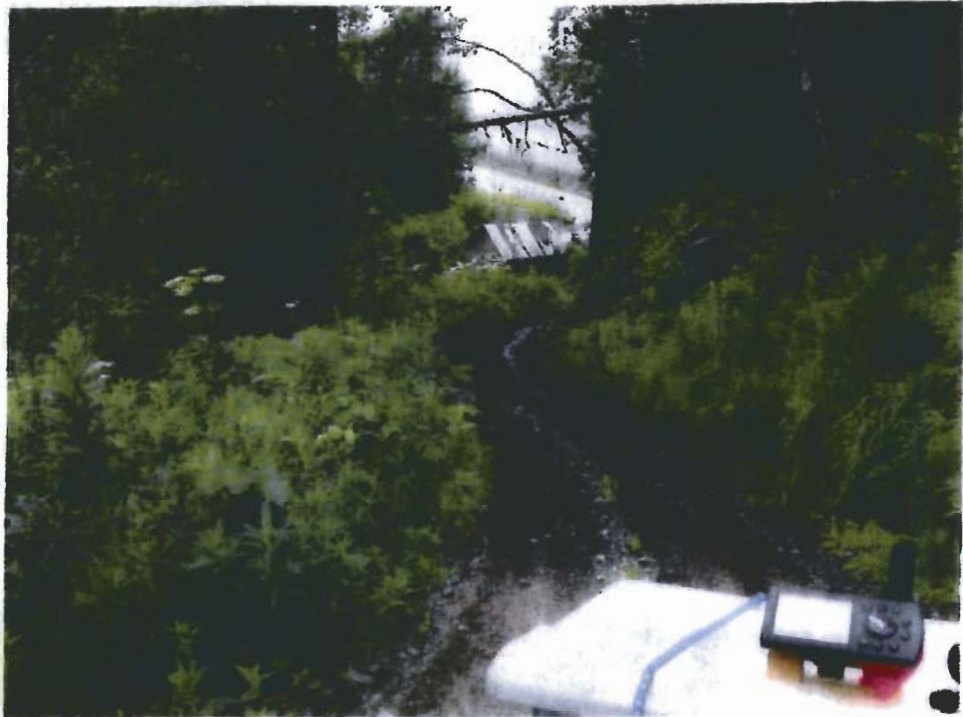
This segment is another over steepened 30% grade. Water is running on the lower section of the segment.

Photo 7. Looking down on upper section of the steep grade rising from the beach between Station 7 and 8. 30% grade. Note water on surface.

Recommended action: Reduce trail grade to less than 20% by cutting material from this segment and extending to west. Utilize local material for tread surface. Grade to width, shape with 5% outslope, and compact.

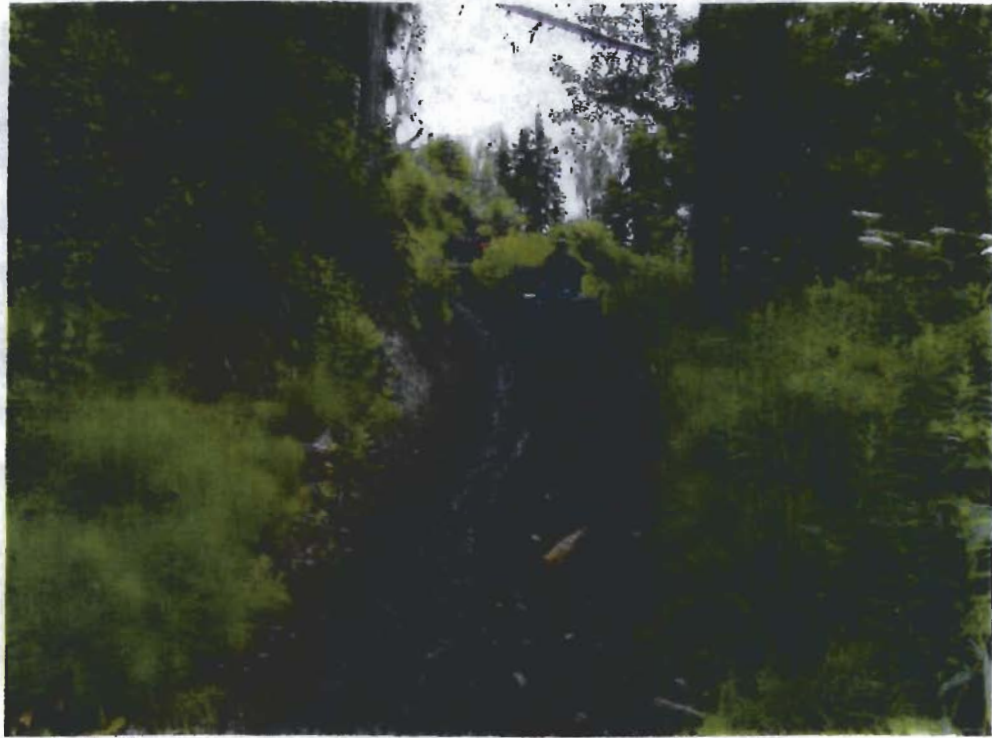
Lower section of the steep grade. Grade runs between 22 and 25%. Still oversteeped with evidence of erosion.

Photo 8. Lower section of steep grade. 22-25% grade.

Recommended action: Reduce trail grade to less than 20% by cutting and grading material and lengthening grade to west. Utilize local material for tread surface. Grade to width, shape with 5% outslope, and compact.

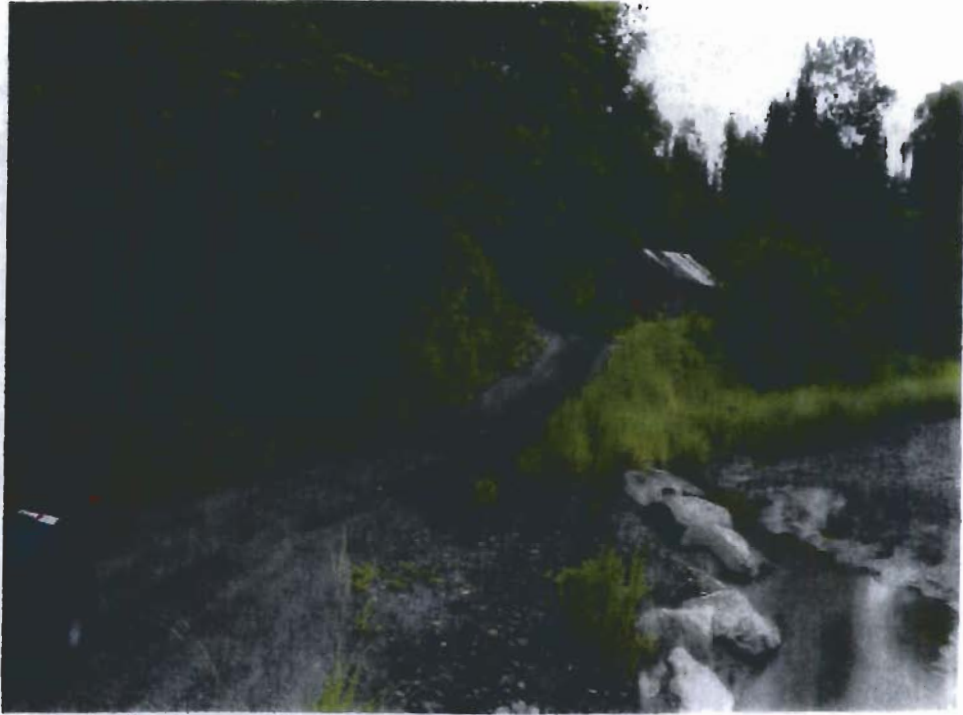
Last run out to the beach. Good substrate. Intercepted water from upslope trail causing some erosion problems. Trail grade less than 10%.

Photo 9. Last run out to the beach.

Recommended action: Buildup grade from materials borrowed from previous segment. Provide 10-15% grade approach to steeper upper trail section. Utilize local material for tread surface. Grade to width, shape with 5% outslope, and compact.
