Exhibit B Jacobs Ladder Drive

TRAIL ASSESSMENT –JACOB’S LADDER TRAIL  
NPS-Rivers, Trails, and Conservation Assistance Program

On Friday, July 1, 2004, Kevin G. Meyer with the National Park Service’s Rivers, Trails and Conservation Assistance Program made a on-site inspection and assessment of the Jacob’s Ladder Trail located approximately 4 miles north of the Capt. Cook State Recreation Area. The work has completed at the request of Ms. Crista Cady, Planner for the Kenai Peninsula Borough. The purpose of the assessment was to make recommendations for improving the trail alignment to a sustainable condition. Those recommendations are as follows:

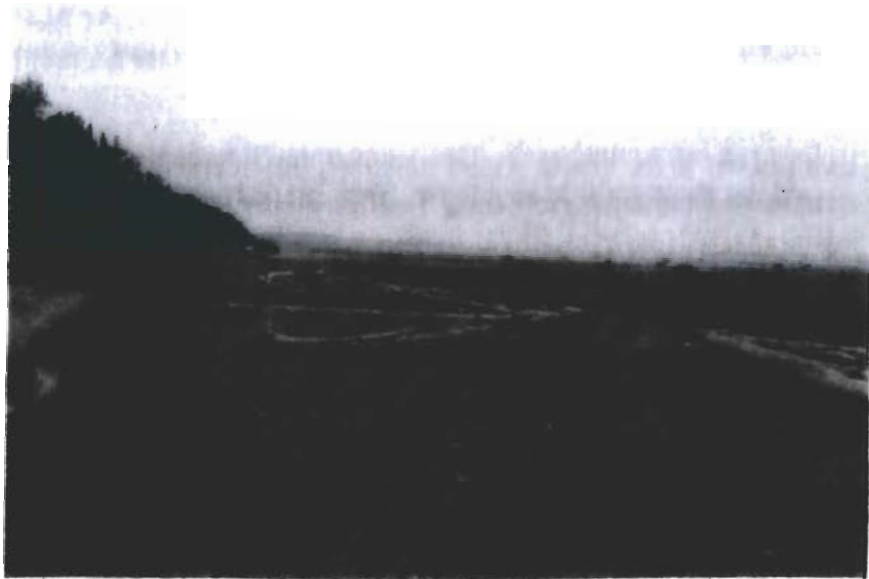
Photo 10. Scene on beach at end of trail.
